Manhole Inspection Summary

Manhole # S21K1_004MH

Insp Date: **4/24/08 10:55 AM**

Location Address: **2556 southdene av**

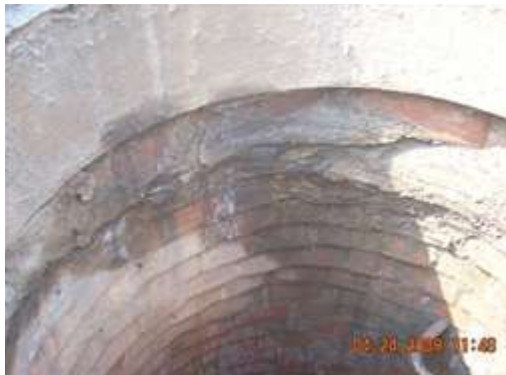
Defect 1

Infiltration: ☐ None ☒ **Joint** ☐ Cracks ☐ Mortar ☐ Roots ☐ Wall

Bench Debris

infiltration @ chimney/frame joint

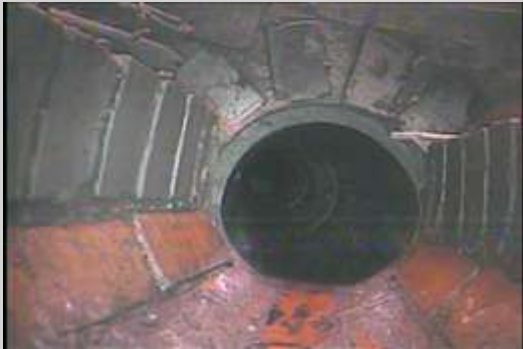
12 O'Clock Outflow

8 in. Circular Gravity Sewer
Pipe Out @ 12 O'Clock

Pipe Height: **8.4** (in.) Rod and Bar (Angled)

Pipe Material: **Clay** ☐ Pipe Lined

Invert Depth: **10.10** (ft.) Flow Characteristics: **Slow**

Infiltration: **None** Pipe Seal Cond: **Sound**

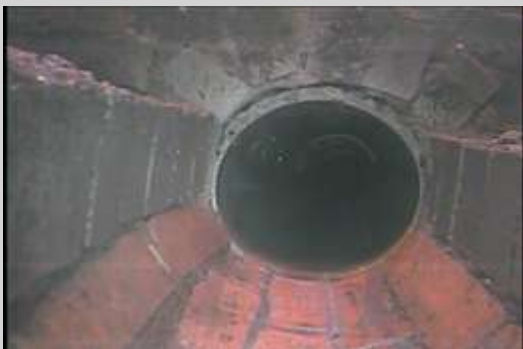
7 O'Clock Inflow

8 in. Circular Gravity Sewer
Pipe In @ 7 O'Clock

Pipe Height: **8.4** (in.) Rod and Bar (Angled)

Pipe Material: **Clay** ☐ Pipe Lined

Invert Depth: **9.79** (ft.) Flow Characteristics: **Slow**

Infiltration: **None** Pipe Seal Cond: **Sound**
